HiGain

QUICK INSTALLATION

HLU-388 LIST 5E LINE UNIT

The HiGain® HLU-388 List 5E is the Central Office (CO) side of a repeaterless T1 transmission system. When used in conjunction with a HiGain Remote Unit (HRU), the system provides 1.544 Mbps transmission on two unconditioned copper pairs over the full Carrier Service Area (CSA) range. The CSA includes loops up to 12,000 feet of 24 AWG or 9,000 feet of 26 AWG wire, including bridged taps. This line unit can be used with HiGain Doubler Units (HDUs) to extend reach.

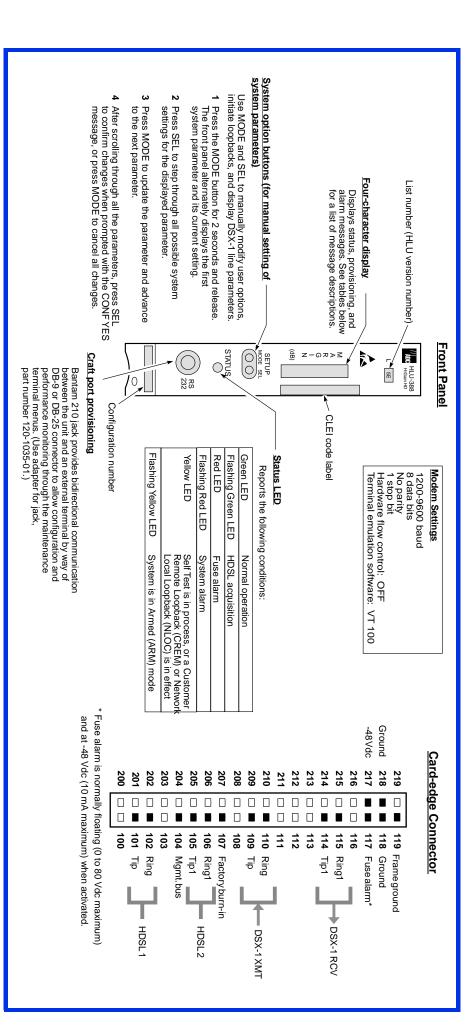
When the HLU powers up, the four-character display illuminates and reports status messages.

- 1 The Status LED flashes green while acquiring each device in the system, and turns a steady green when the entire system is operating without any alarms.
- 2 The four-character display reports margin (signal-to-noise ratio) readings and insertion loss.
- 3 If the status LED is not solid green, the display reports alarm conditions (see the Front Panel Alarm Messages table inside).
