HiGain

QUICK INSTALLATION

HLU-231 LIST 8F LINE UNIT

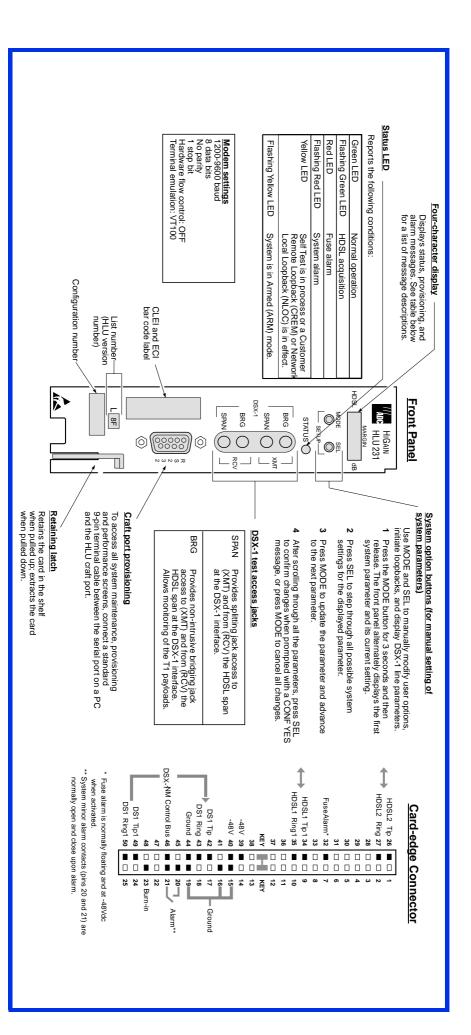
- 1 Access the Maintenance Terminal screens by pressing the **SPACEBAR** several times.
 - a Set the date and time (select Set Clock from the Maintenance Terminal Main Menu).
 - **b** Set the circuit IDs (select **View System Inventory** from the Maintenance Terminal Main Menu).
- 2 Access the System Settings screen from the Maintenance Terminal Main Menu to change the default settings of any system parameters.
- 3 Access the View Troubleshooting screen from the Maintenance Terminal Main Menu to view a graphical analysis of any potential system problems.
- 4 When the HLU has been successfully installed and provisioned, clear Span Status, Performance Data, Performance History, and Alarm History screens to ensure accurate data and alarm reporting thereafter.
